ROPELLER SAFETY INSTRUCTIONS 3/17

Applies to all Neuform three-bladed variable pitch propellers

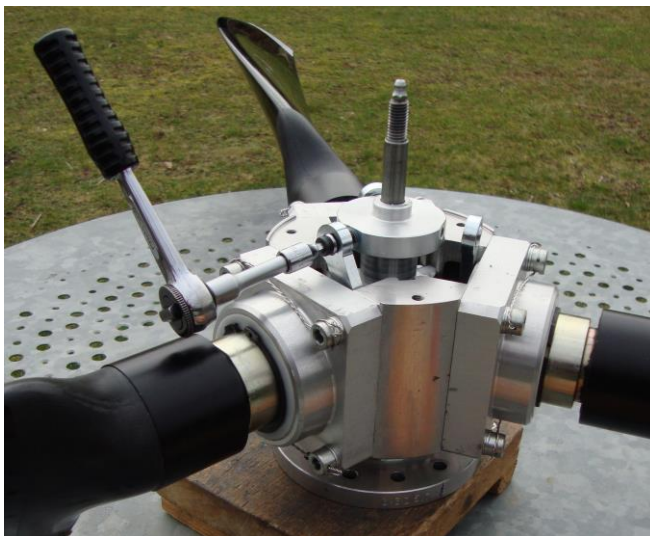
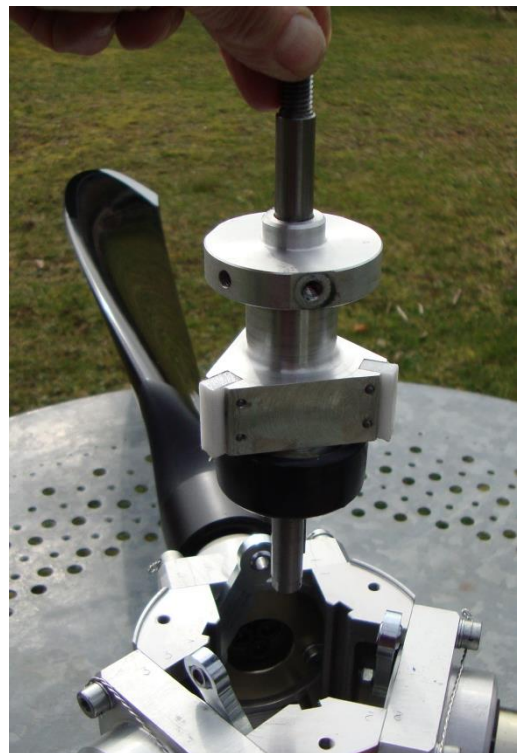
Below: Dismantling the rod ends

Remove the propeller from the engine and remove the push-pull rod (left-hand thread!)
Remove the stop nut (measure position before) and unscrew the head cover
Unscrew the rod ends from the bearing housing
Pull the bearing housing out of the hub
